Extra Holes Save Bowls

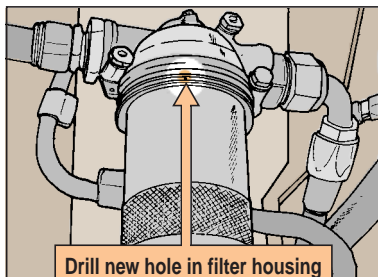
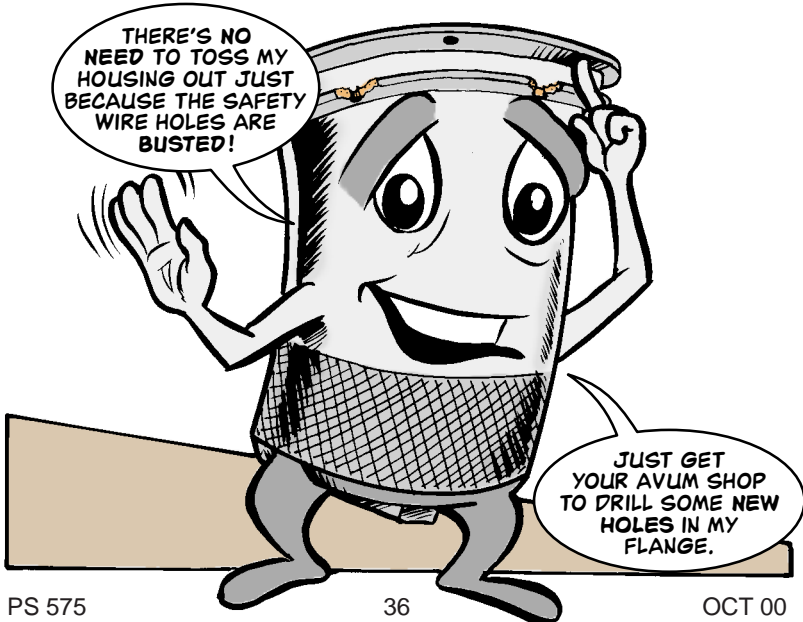
The metal around the safety wire holes on the external oil filter bowl of your Kiowa Warrior is easily broken. When that happens, TM 1-1520-248-23 says to replace the whole bowl.

An upcoming change to the TM will let AVUM shops drill additional holes in the housing flange instead of replacing the bowl.

Each new hole should be 0.048 to 0.057 inch in diameter and should be drilled at a point on the bowl that's 30 to 45 degrees from the damaged hole.

Treat the edge of the new hole with alodine conversion coating to prevent corrosion. The coating is listed in your TM's expendable supplies and materials list as Item 57, NSN 8030-00-057-2354.
